Crash During a Landing Approach

MAY 16, 2018.

Aircraft and Railway Accident Investigation Board
Republic of Korea

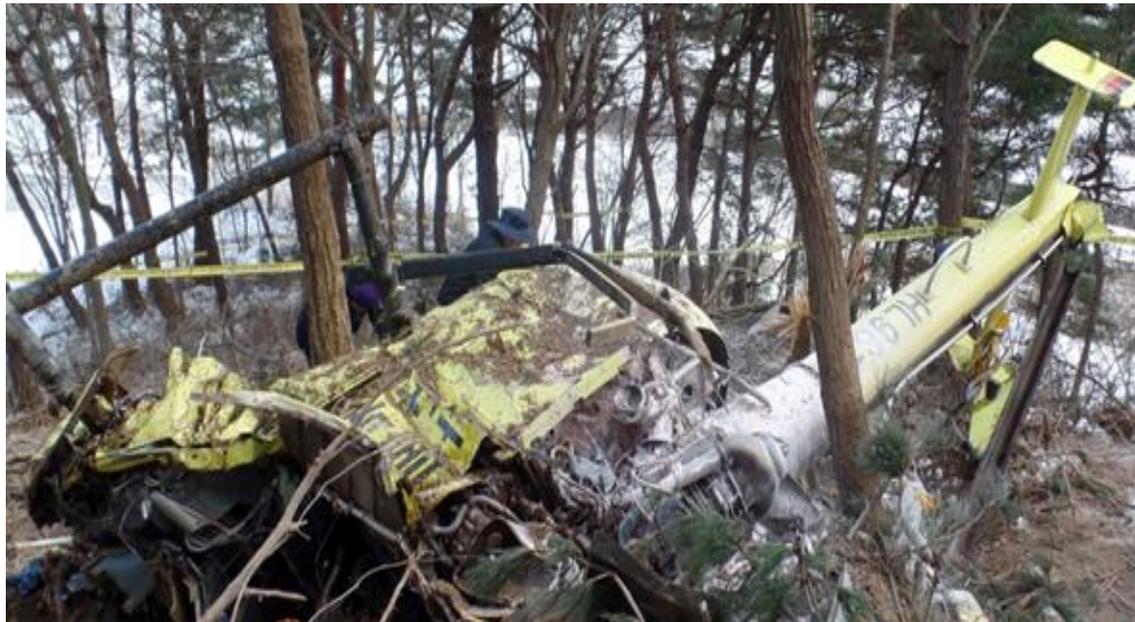
- Purpose of Flight: Forest Fire Patrol
- While approaching a landing site, the Rotorcraft suddenly spun to the right about 10 times at an altitude of 30 to 40 meters and flew towards a nearby hill with a nose-down attitude

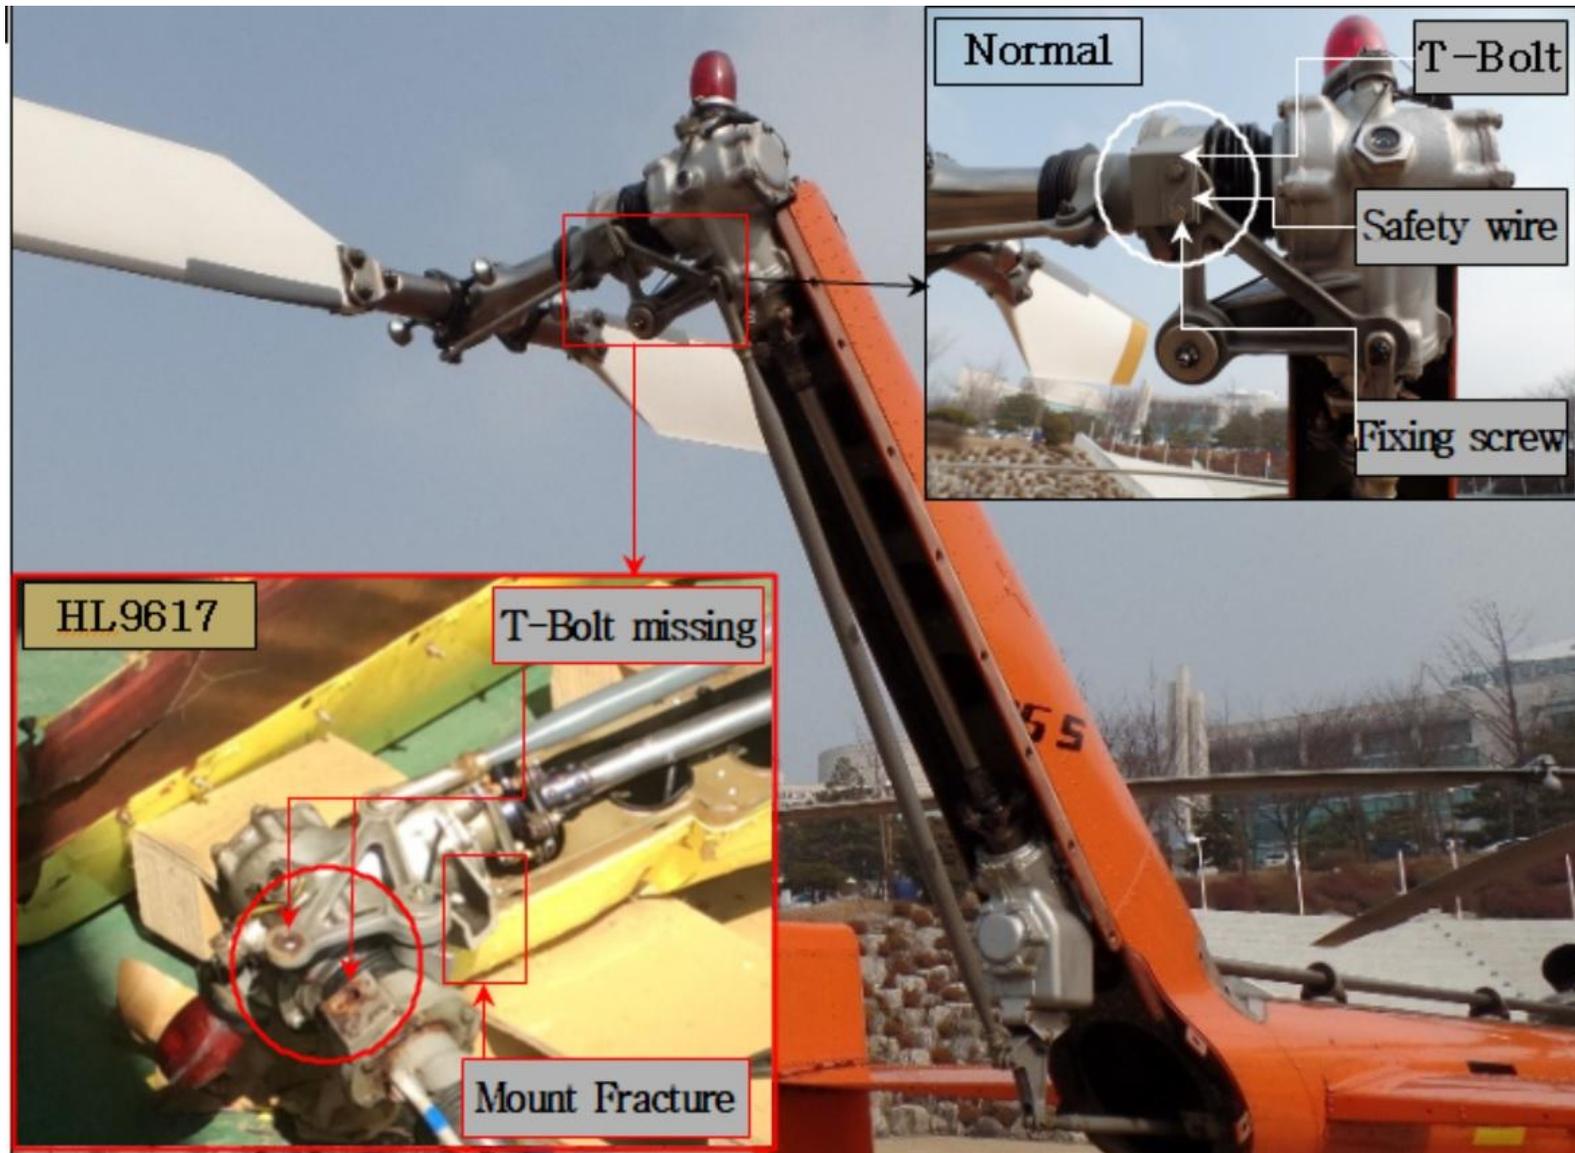
- Field Investigation
 - The tail rotor pitch control bell-crank attached to the vertical stabilizer had been separated from the pitch control sleeve because the T-bolt had been lost
 - It is concluded that the T-bolt was tightened without fixing screws.
 - T-bolt had to be installed in the TGB, and the T-bolt is tightened by two fixing screws and one safety wire to prevent it from falling out during flight.

- Probable Cause
 - As T-bolt was lost during flight due to inadequate aircraft maintenance, the bell-crank became separated from the tail rotor pitch control sleeve, which caused the aircraft to experience a loss of yaw control, thereby resulting in crash.
 - When the rotorcraft experienced a loss of yaw control, the captain could not perform appropriate emergency procedures.

- Contributing Factor
 - Sejin Aviation inadequately performed aircraft maintenance in that the aerial work operator installed the unserviceable TGB which had lost airworthiness and failed to check the fastening of T-bolt fixing screws.
 - As Sejin Aviation inadequately provided its flight crew with emergency procedures training, the captain could not perform appropriate emergency procedures in an emergency situation.

- To Sejin Aviation
 - Take measures to improve maintenance practices including a compulsory check on a valid airworthiness certificate of a replacement part.
 - Take measures to enhance emergency procedures training to ensure that pilots can improve their ability to respond to emergency situations.
