Recent Developments and Experiences

Background information for ITSA Member States prior to the May 2021 Microsoft Teams tele-conference

State: **Australia**

Aviation – loss of Coulson Aviation EC130Q LAT on 23 January 2020

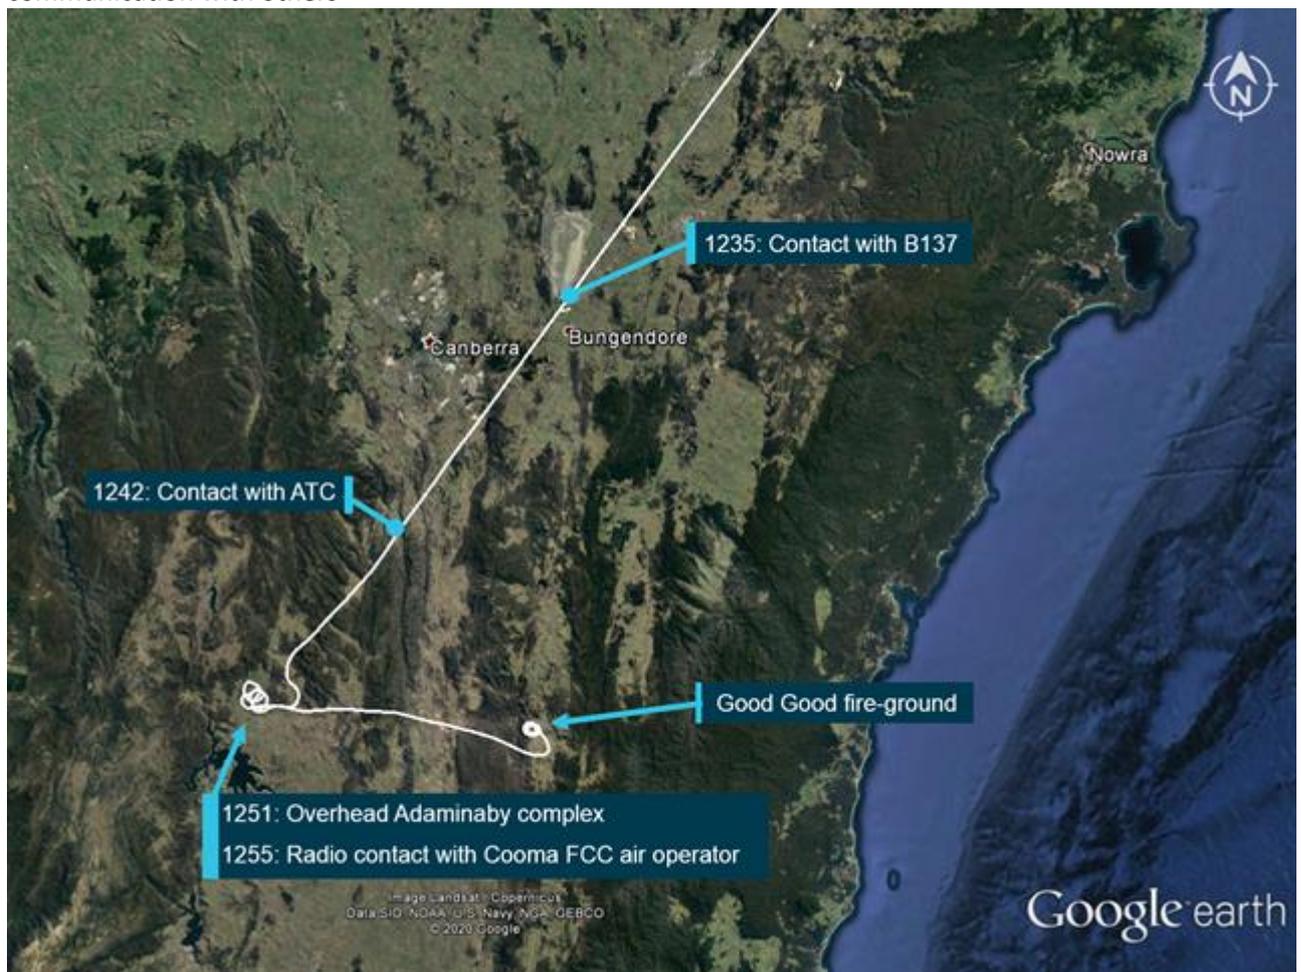
Figure 1: Flight path overview (in white), including the times and locations of where the crew of B134 was in communication with others

The automatic dependent surveillance broadcast (ADS-B) data showed that after arriving at the Adaminaby fire-ground (Figure 1), the crew of B134 completed several circuits at about 2,000 ft AGL. At about 1255, the crew contacted the air operations officer at the Cooma FCC by radio and advised them that it was too smoky and windy to complete a retardant drop at that location. The Cooma air operations officer then provided the crew with the location details (co-ordinates) of the Good Good fire, about 58 km to the east of Adaminaby, with the objective of conducting structure and property protection near Peak View.

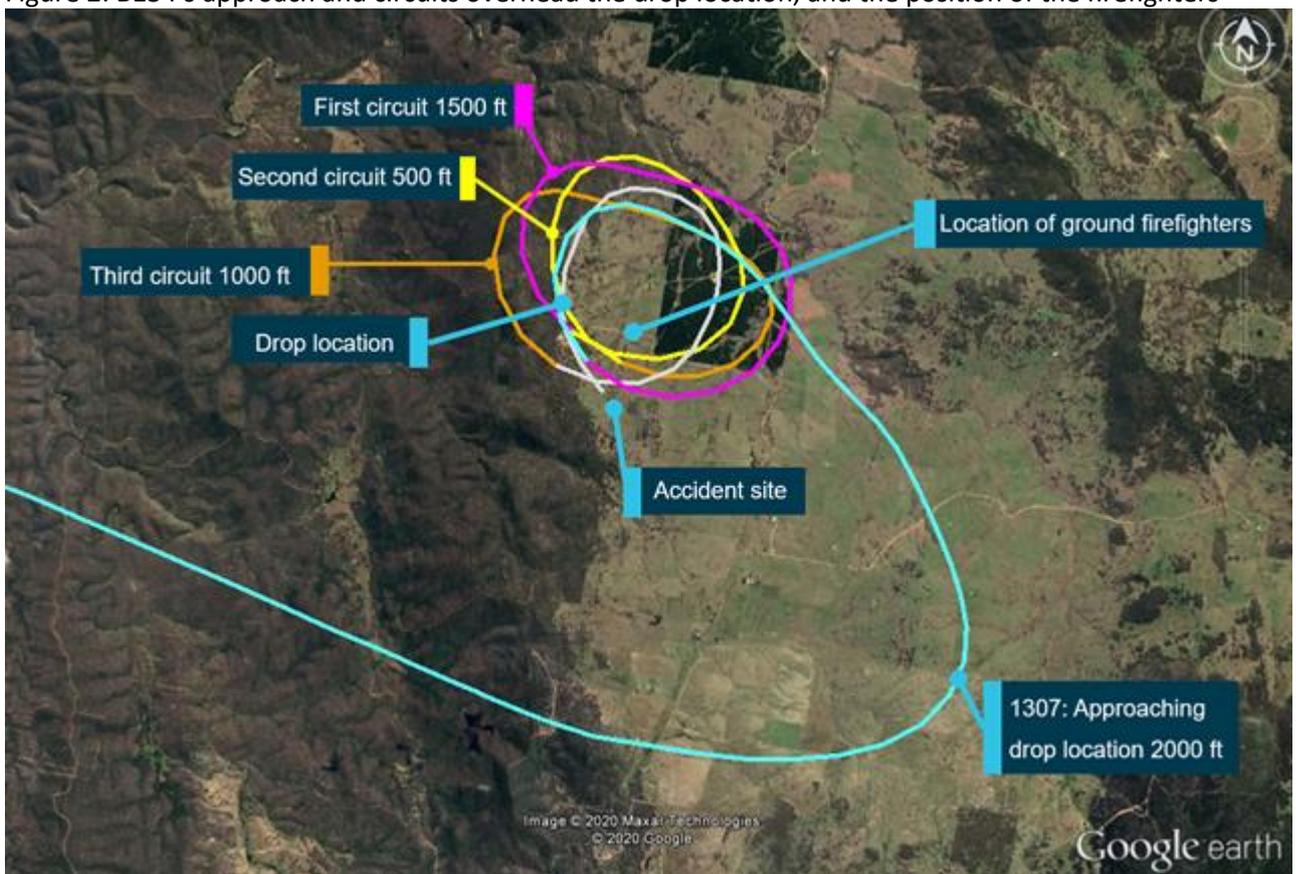
Figure 2: B134’s approach and circuits overhead the drop location, and the position of the firefighters

At about 1307, B134 arrived overhead the drop area (Figure 2). From the aircraft’s recorded tracking data, the crew conducted three left circuits, at about 1,500 ft, 500 ft and 1,000 ft AGL respectively, prior to commencing the drop circuit.
