Crash During a Landing Approach

MAY 16, 2018.

Aircraft and Railway Accident Investigation Board
Republic of Korea

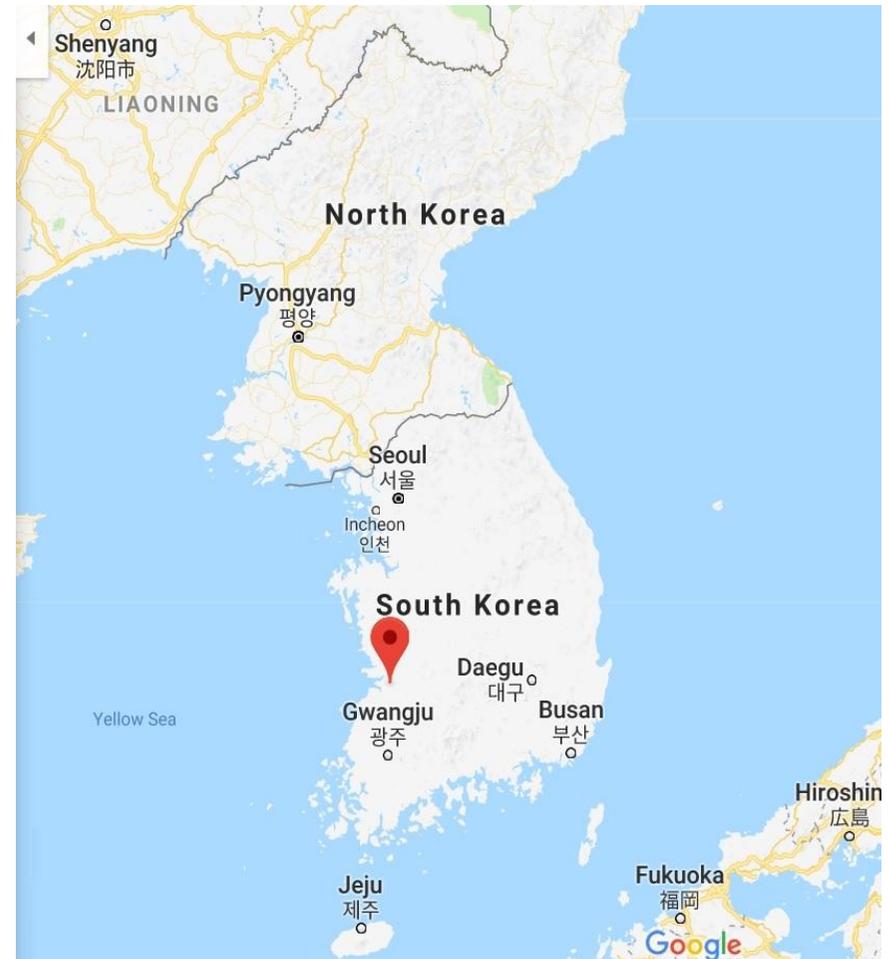
- Date : JAN 30, 2016. 5:00PM
- Operator : Sejin Aviation
(aerial work)
- A/C Manufacturer : MBB Co.
(Airbus Helicopter)
- A/C Type : BO105CBS-5
(Rotorcraft)
- Captain : fatally injured
- Aircraft : totally destroyed
- Occurrence: crashed into a hill
while approaching a landing site
